JOINT SEAL
Waterproofing

ELEVATOR PIT WATERPROOFING PROFESSIONALS

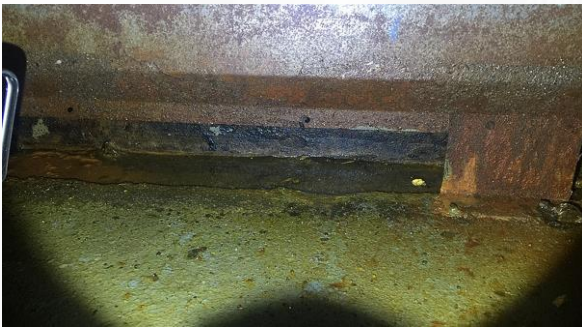
DAMP WALLS

The darker wall surface at the bottom of the pit can indicate previous flooding that reached that level and/or wall deterioration due to water saturation.

Damp Walls

The darker wall surface at the bottom of the pit can indicate issues.

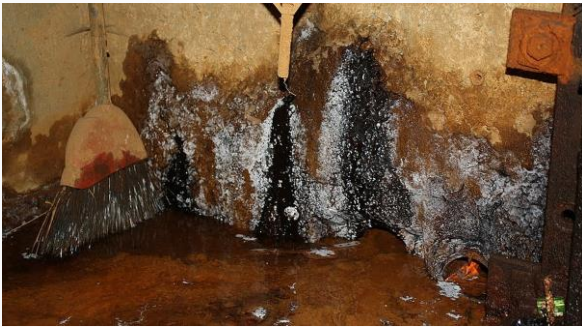
CALCIUM DEPOSITS

Caused by a significant flow of water seeping from the outside through larger wall cracks. Elevator equipment will be damaged if no repairs are done.

Calcium in Wall Cracks

Calcium deposits on shaft walls show problems with leaking.

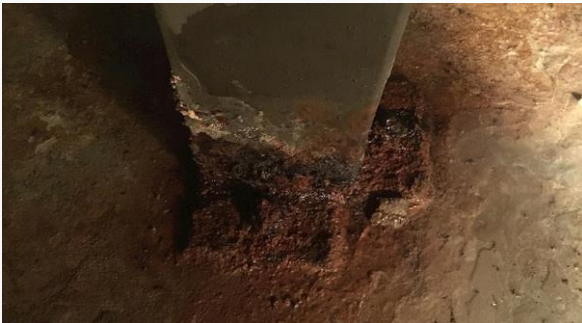
RUSTED METAL

Indicates flood level, possible wall saturation, and damage to elevator equipment. The shaft can start leaking at any time, causing further damage.

Rusted Metal

Rusted elevator equipment reveals previous flooding levels.

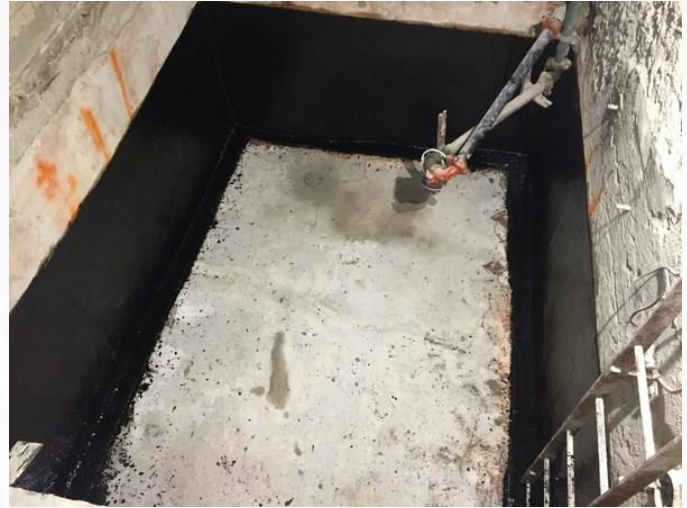
Basalt coating for floor/wall corners

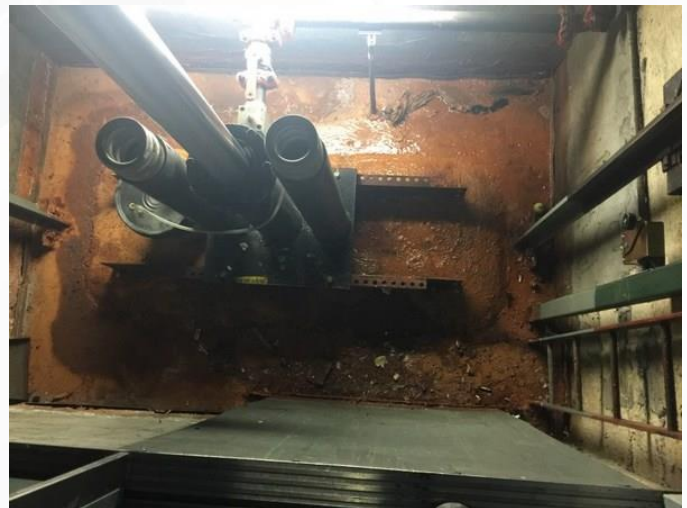
Leaking housing waterproofed

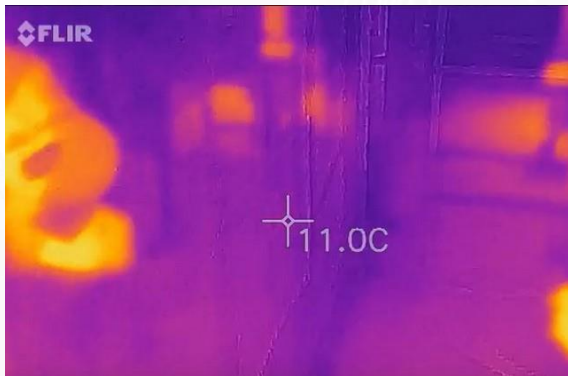
A saturated floor/wall corner

An infrared camera makes any leakage evident. The darker the colour and the lower the temperature, the greater the water saturation problem.

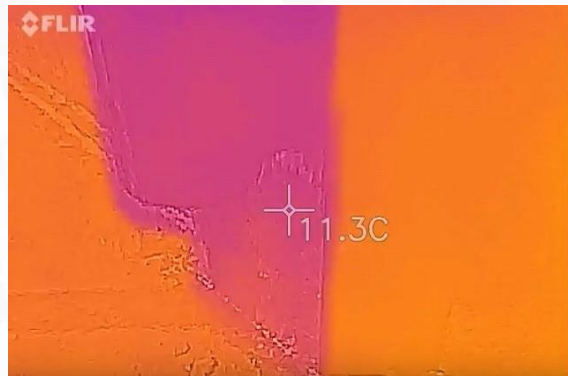
A wall crack

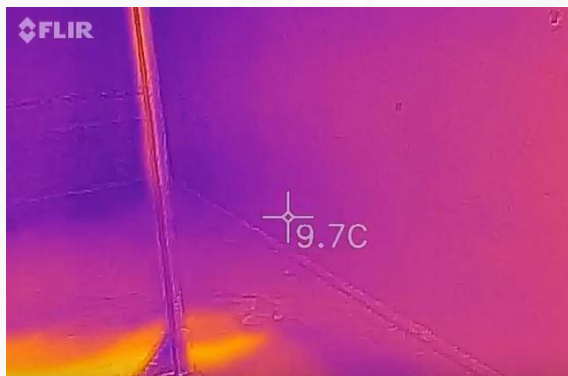
A saturated block wall

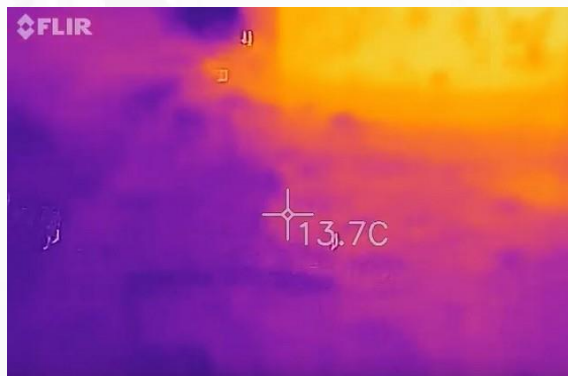
Leaking around piston housing

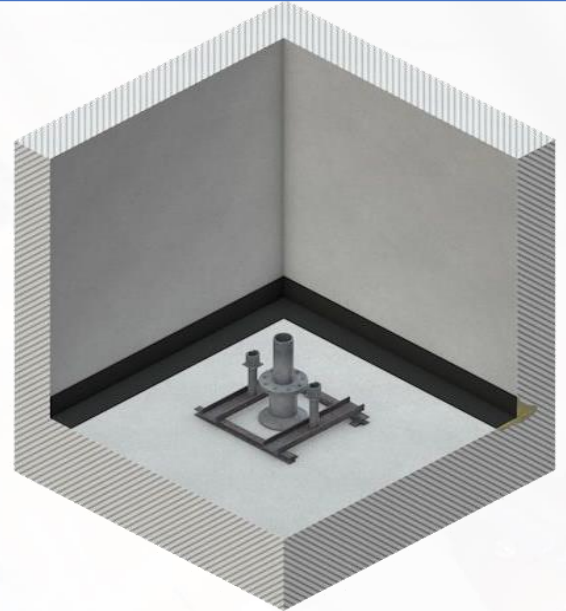
i FLOOR/WALL CORNER WATERPROOFING

1. Adhesive layer is applied.
2. Patching is done with regular or polymer cement.
3. Fiberglass layer is installed.
4. Basalt coating is applied.

Efficiently waterproofed with a triplex application.

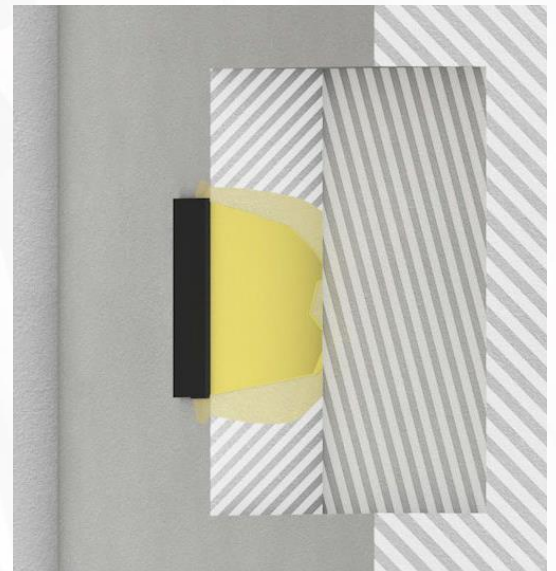
i FLOOR/WALL CRACK REPAIR

1. The crack is routed with a saw.
2. Adhesive is applied.
3. A patch is installed.*
4. Waterproofing primer is applied.

* For patches of less than a ¼ inch thick, polymer cement is used.

Crack repair helps in preventing elevator shaft flooding.

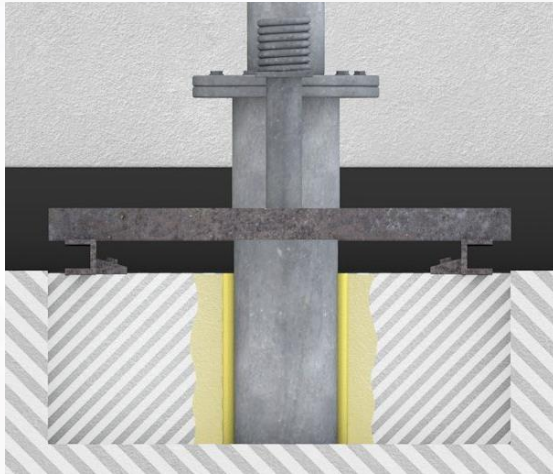
i PISTON HOUSING WATERPROOFING

1. Water accumulated around the piston is removed.
2. The area is cleaned thoroughly.
3. The space is injected with a liquid rubber material.

Waterproofed through liquid rubber injection.

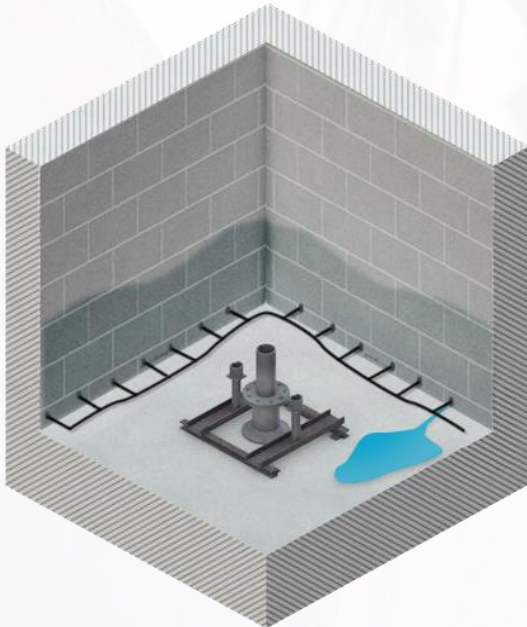
i BLOCK WALL WATERPROOFING

1. A drainage system is installed.
2. Walls are waterproofed and repaired.
3. A rubber / fiberglass membrane is installed.

Includes drainage system installation and rubber fiberglass membrane.
